Land off Draycott Road, Breaton

# Arboricultural Impact Assessment & Method Statement

**Issue 1:** 12<sup>th</sup> February 2026

**Ref:** GLY0172

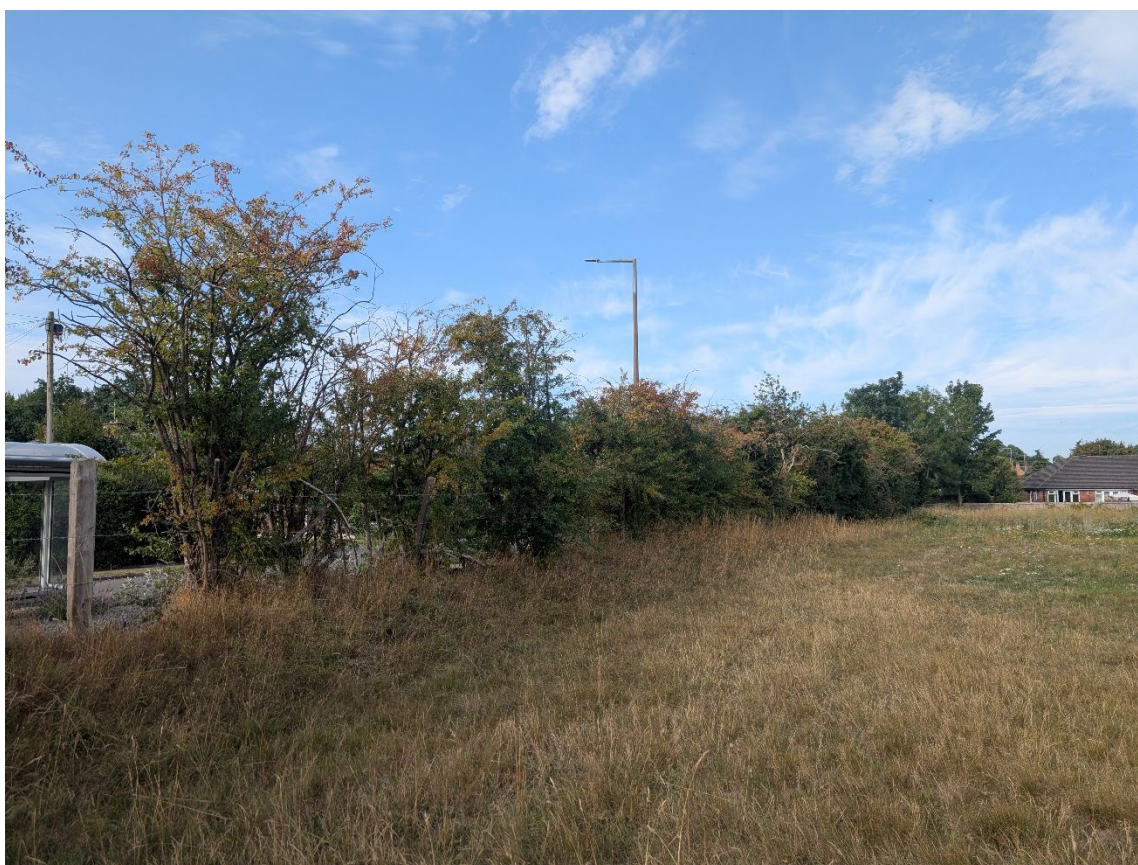
- 3.1 The survey commenced within the southwest of the Site and followed a broadly anti-clockwise direction around field boundaries included within the survey area.
- 3.2 In the southwest, the field boundary between Western Mere Close and 100 Draycott Road comprises a group of series of trees in its western corner (T001 to T003 inclusive) and the existing hawthorn hedgerow adjoining the roadside (H004). The hedgerow makes a positive contribution to the streetscene and is identified as moderate quality; category B. T001 to T003 are identified as categories C and U, due to their suppressed and poor form.

*Image 1 – Displaying H004, with T001 and T003 visible distantly adjacent the bungalow.*

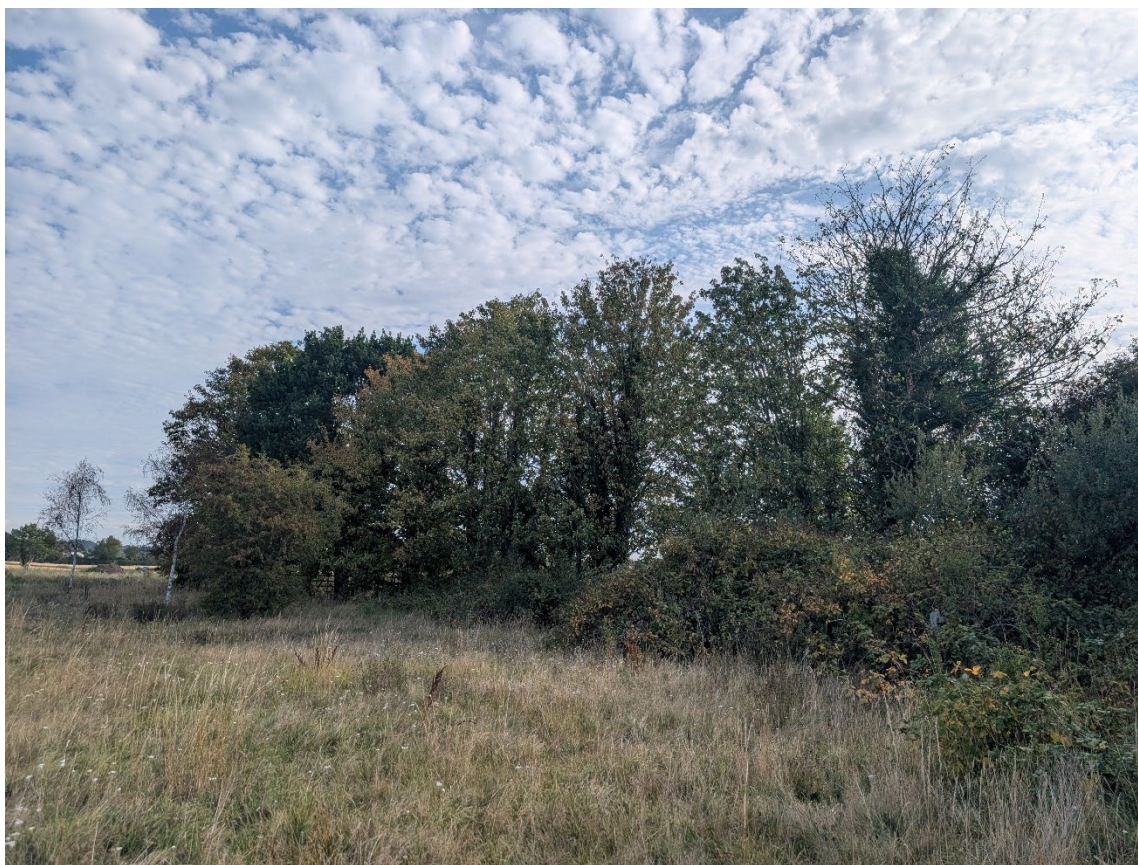
- 3.3 A network of hedgerow, young and mature trees extend around the boundaries of 96 and 100 Draycott Road adjoining the Site, comprising trees T005 to T023 inclusive. A series of recent young trees are present along the field edge, including T005 to T007, T010, T011 and T014 to T016 inclusive. These are identified as categories C and U, owing to their limited significance

and evidence of decline. Mature tree cover is evident within the grounds of the adjoining properties, and throughout the north boundary of 96 Draycott Road. These trees include T009, T013, T017, G018, T022 and T023. These features include a mix of broadleaf species that have developed as individuals or, in the case of G018, as a codominant group of predominantly sycamore. All trees attract moderate quality and are identified as category B, forming a treed setting to this part of the Site boundary. While some trees were inaccessible for inspection due to land ownership constraints, reasonable estimations of dimension, location and condition have been recorded.

*Image 2 – Displaying T014 to T016 and G018.*

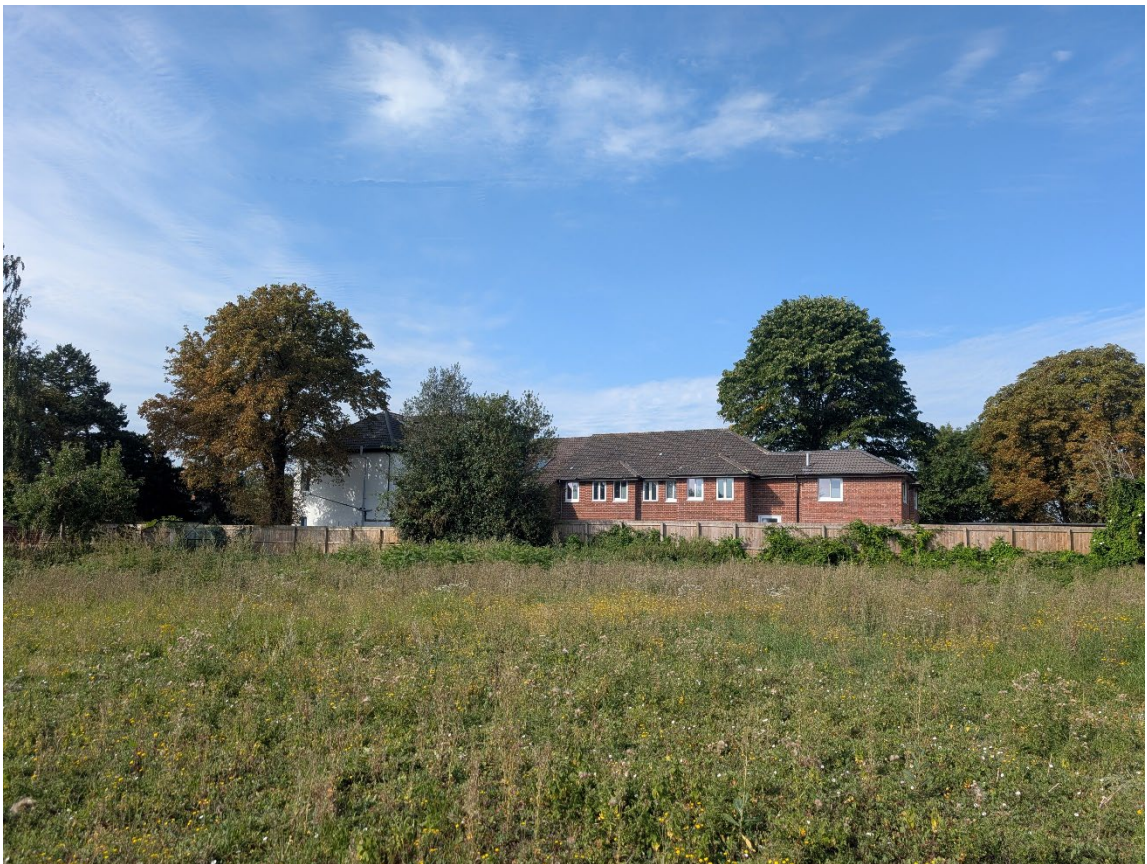
- 3.4 The east boundary of 96 Draycott Road is more sparsely vegetated, with hawthorn hedgerow H019 appearing in an advanced state of decline and is identified as category U. Remnant hedgerow vegetation intersperses the wider boundary, including T020 and G021, both identified as category C and representing unremarkable features of poor form.

*Image 3 – illustrating G021, with horse-chestnuts T022 or T023 visible to the left and right.*

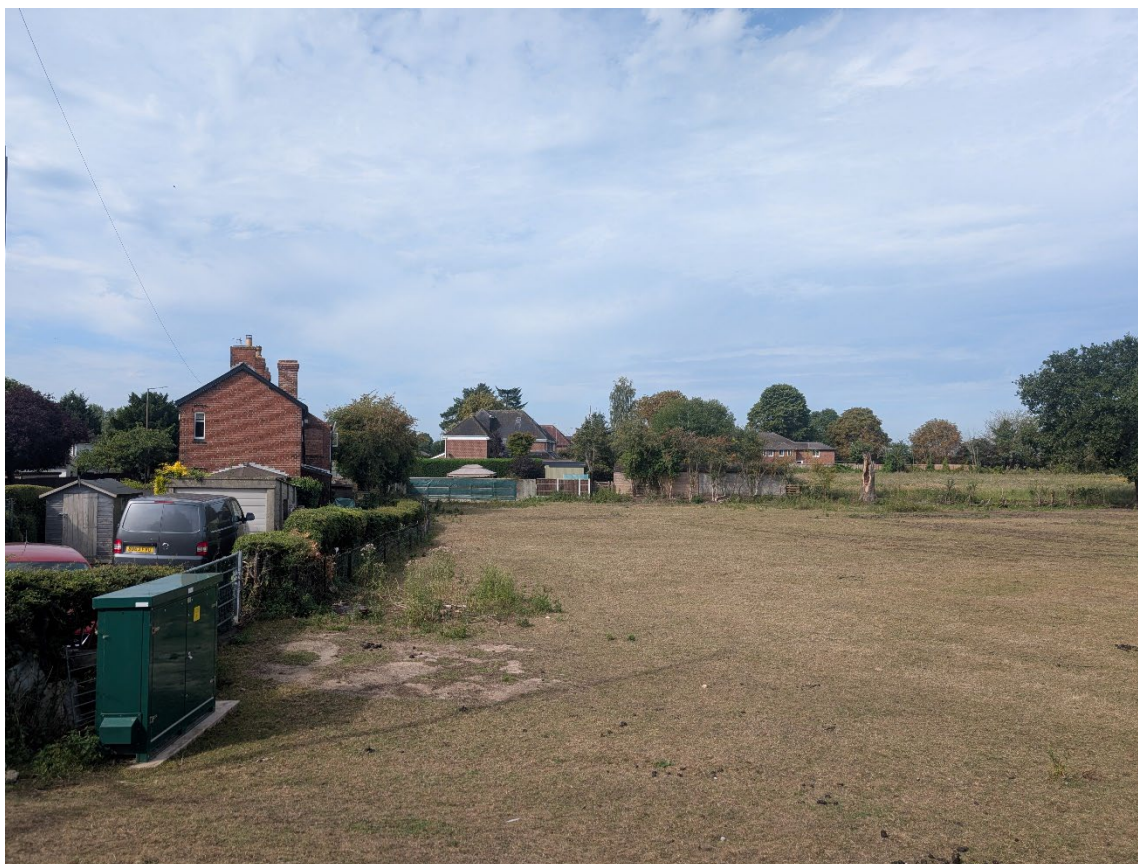
- 3.5 The easternmost field includes similar degraded field boundary vegetation. Remnant sections of hedgerow are present at H025, H026 and H031. These flank residential boundaries and are fragmented, identified as category C. H030 separates fields on a north-south axis, but has been reduced to stumps and is identified as category U.

*Image 4 – illustrating H026, H031 and H025 at the rear of properties on Draycott Road.*

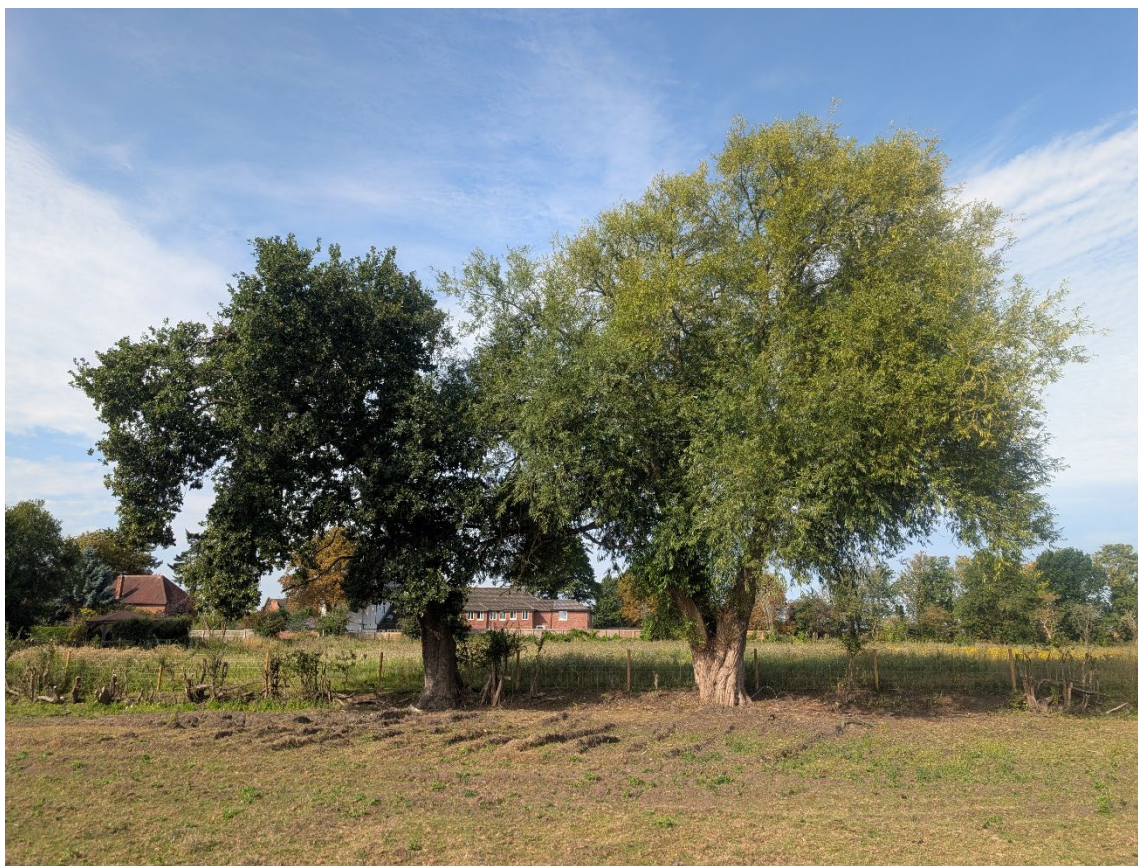
- 3.6 Scattered mature trees are present around the wider field boundary. T027 is a remnant oak stem that has failed at approximately 2m with a single pocket of very limited epicormic regrowth. It is identified as category U, but may be retained for habitat interest.
- 3.7 T028 and T029 are a late mature oak and willow that have developed codominantly. Both trees exhibit crown damage consistent with their age and would benefit from positive management. T028 has a notable stem diameter and while being representative of a late mature example at this stage, could be managed to promote veteranisation over future years. Both trees are of moderate quality and have material conservation value, identified as category B.

*Image 5 – showing T028 and T029.*

T028	Pedunculate oak <i>(Quercus robur)</i>	M	980	2	15	4	8.5	8	8	Good	Poor	Late mature oak with historic damage to southwest secondary limb, with open wound on tension side of branch. Remedial pruning and major deadwood visible. Wider canopy suppressed to the north by adjacent willow, with typical deadwood and socket cavities.	Promote veteranisation through crown managemen (3)	B1,3	20+ Years	Radius: 11.8m. Area: 437 sq m.
T029	Crack willow <i>(Salix fragilis)</i>	M	680 700 700	3	20	10	7	6	9	Good	Fair	Large willow with typical broad habit. Previous stem failures/removal visible at 1-2m with 3no primary stems remaining. Asymmetry to east due to past stem loss. Stem diam. below branching is 1450mm, with substantial flare from union form.	Crown reduce 4-5m to mitigate future stem failure (2)	B1,3	20+ Years	Radius: 14.4m. Area: 651 sq m.
H030	Common hawthorn <i>(Crataegus monogyna)</i>	M	150	0	1	Refer to Tree Constraints Plan.				Poor	Poor	Declining hedgerow with large gaps and advanced decline, reduced to stumps.	Remove and replace (2).	U	< 10 years	N/A

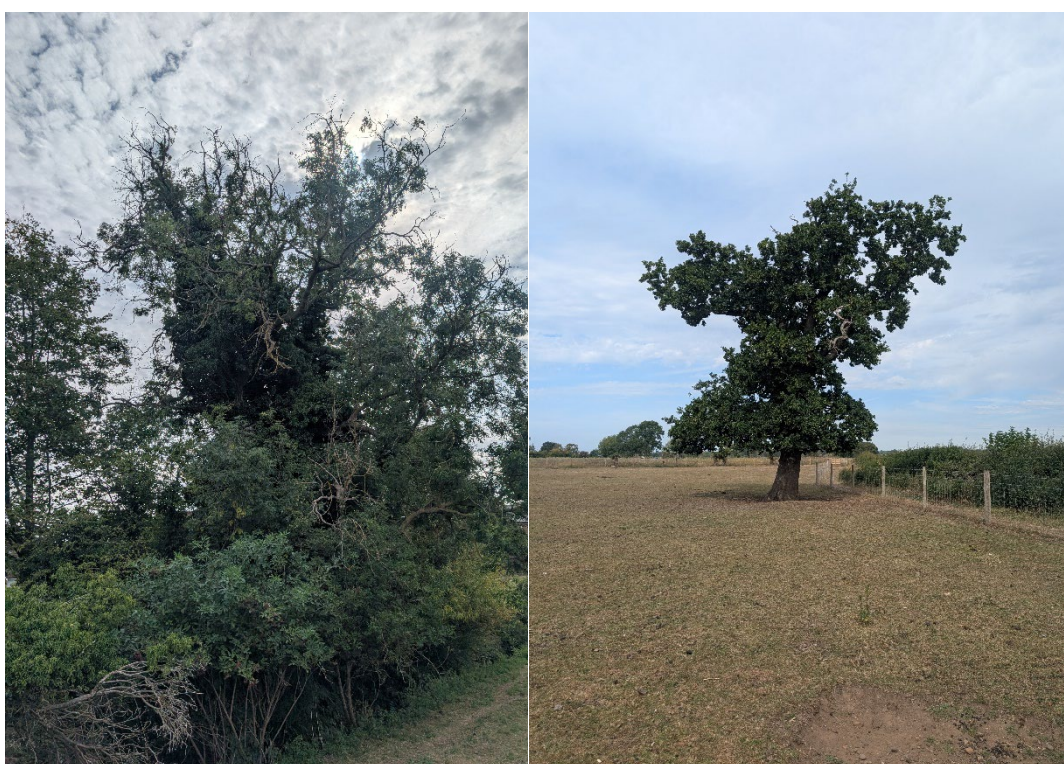
- 3.10 To the north, H043 is a more intact section of hedgerow defining the field boundary and adjacent public right of way. T042 is located just within the field boundary. It is a relatively small mature tree, with some evidence of historic crown damage and major deadwood. Heavily

desiccated fungal fruiting bodies were visible at the stem base, likely associated with *Ganoderma sp.* or *Inonotus dryadeus*. Fungal colonisation is likely to be causing a degree of basal decay in the tree, however, given its limited crown size and the durability of the species against such natural processes, this is unlikely to represent a significant impact on the tree's remaining contribution. The tree is of moderate quality and has material conservation value, with early signs of retrenchment, likely to increase in ecological significance over time; category B.

*Images 6 and 7 - illustrating crown dieback in T039 and the oak T042.*

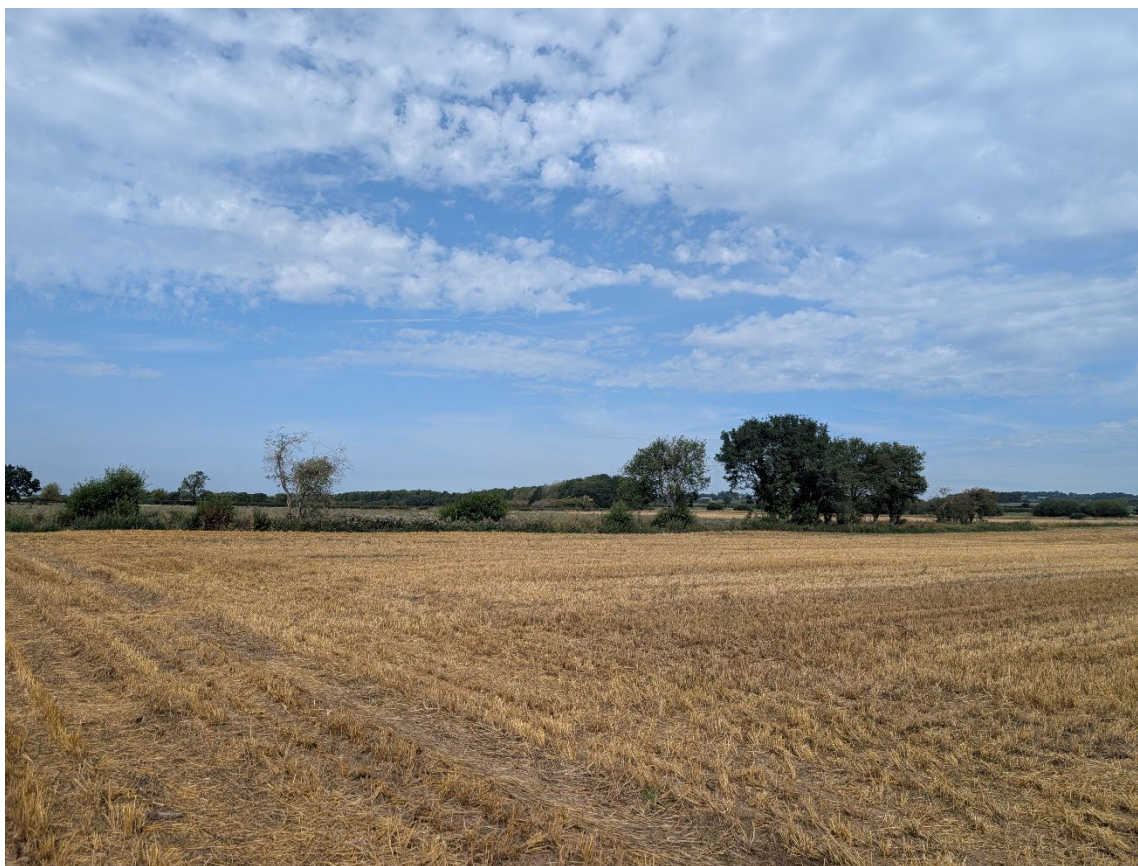
- 3.11 Tree cover to the north of the survey area extends across field boundaries and the former school site. The majority of recorded features represent commonplace field boundary vegetation, including scattered small trees and remnant hedgerow including ash, willow, field maple and hawthorn (T044 to T053 inclusive). These features are predominantly of low quality; category C.

*Image 8 – illustrating north field boundary including T048 to G051.*

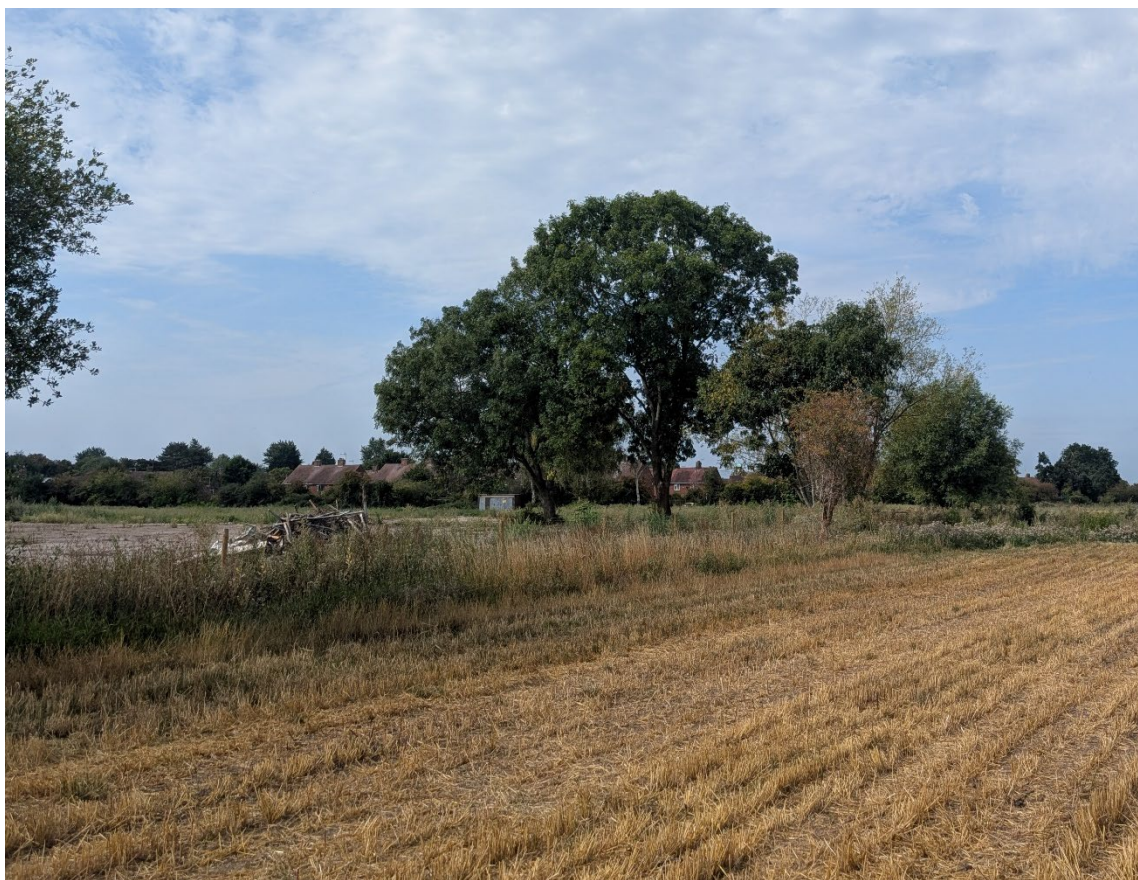
- 3.12 Of note, T054 and T055 are a large pair of ash set within the former school area. T055 displays a dominant canopy, with T054 notably more suppressed. Hardstanding extends across the south RPA of the trees associated with the former Site use. Some disturbance to ground levels is evident from historic demolition. Beyond this, the trees appear in normal condition, but with notable structural interdependence due to their cohesive development. They are identified as category B.

*Image 9 – showing T054 and T055 and adjacent smaller tree cover.*

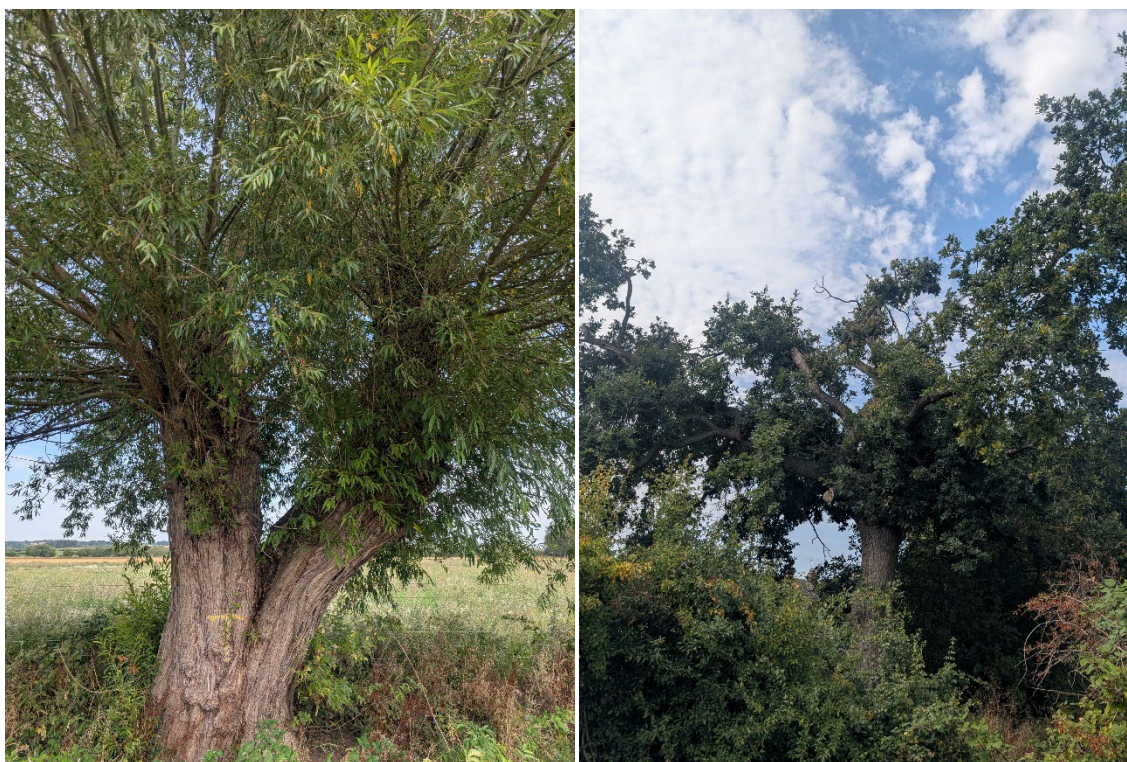
- 3.13 T056 is a substantial willow that has been significantly reduced historically and has now regrown as a pollard. A drainage ditch extends between the tree stem and surviving hardstanding within the site. The tree has a notable girth but one that is not uncommon for the species given its propensity to develop broad, basal circumference associated with typical multi-leadered form. Whilst as a result of historic works the form of the tree is now poor, it attracts moderate quality and is identified as category B.

*Images 10 and 11 – illustrating the willow T057 and damaged oak T062 (TPO).*

- 4.15 T057 (TPO) is currently maintained in a compact, pollarded form. Following significant reduction, willow sp. benefit from continued cyclical management due to the development of weak unions. Shading is unlikely to be an issue, as the tree is positioned to the north of the dwellings. However, if allowed to regrow unchecked, it could become overbearing to the proposed gardens immediately to the south, or present risk of stems failing into gardens. Providing the tree remains under its current management regime, the impacts are likely to be negligible, but a suitable management strategy would be required. Again, any management would be subject to the safeguard afforded by the existing TPO.
